Trinity Guardrail End Caps In & Near London Ontario - Survey of Locations & Condition

Posting Date: 09-Oct 2014

Survey of Trinity End Cap Location & Condition

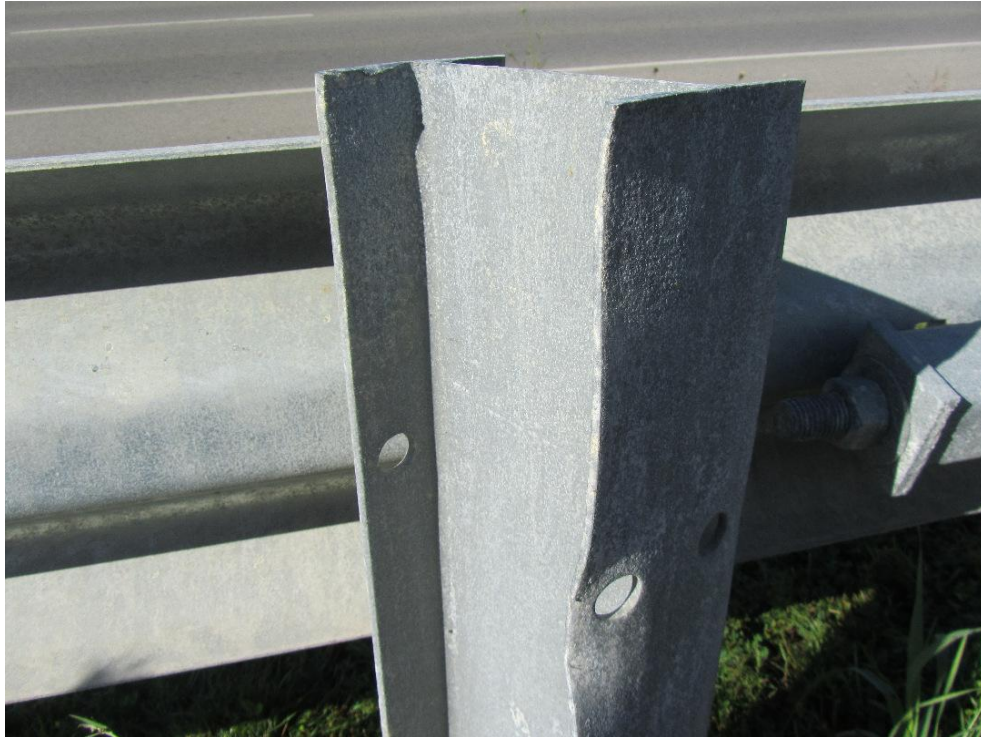
Figure 80: View of deformed status of the anchorage post.

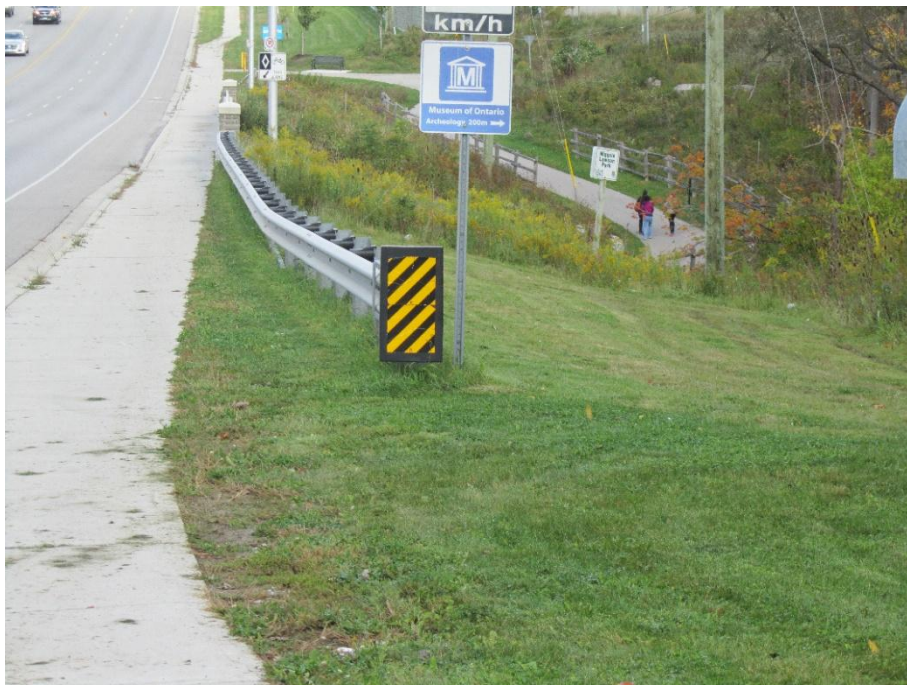
Figure 81: Overall view of south end cap of east guardrail.

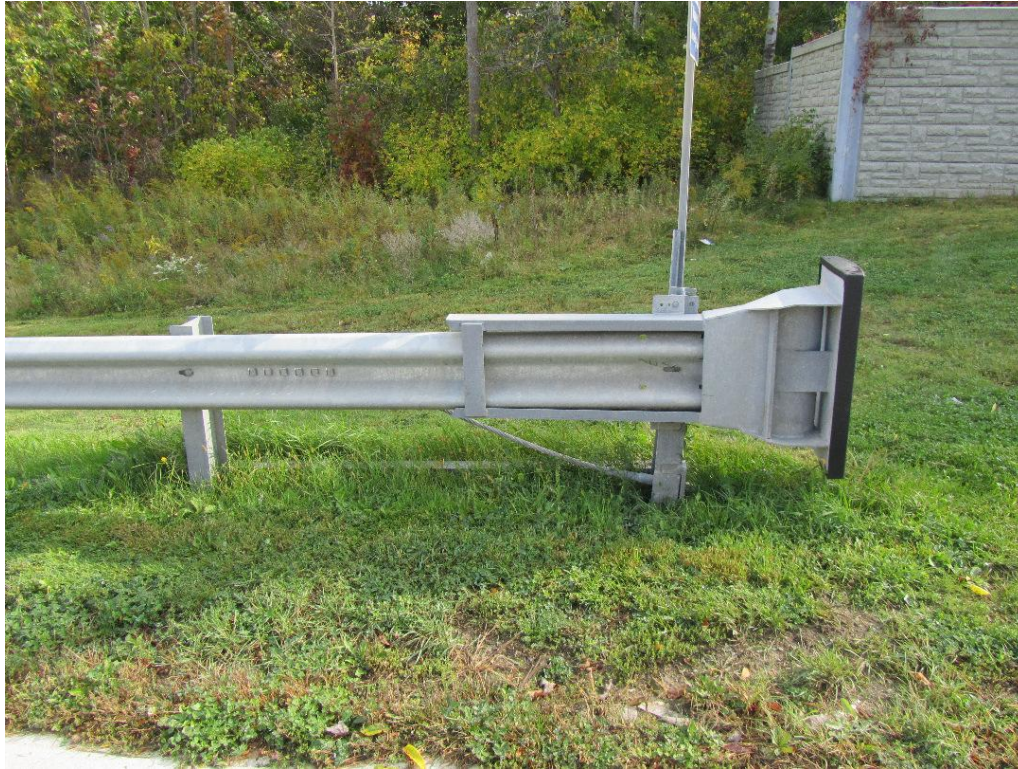
Figure 82: Street side view.

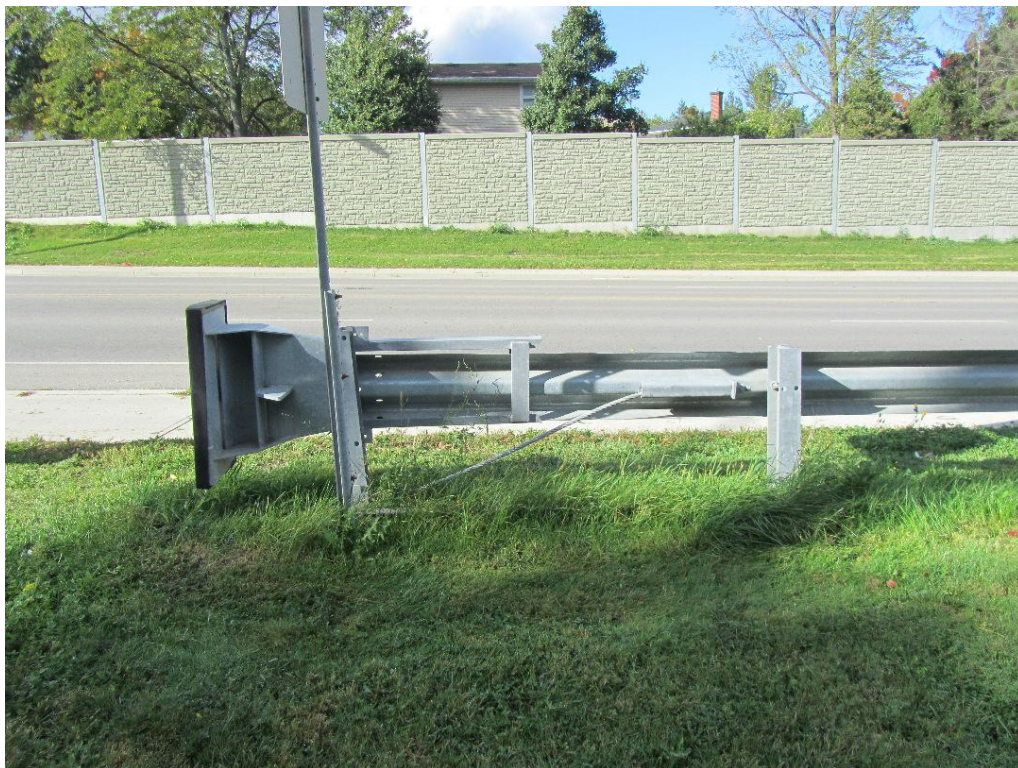
Figure 83: Ditch side view.

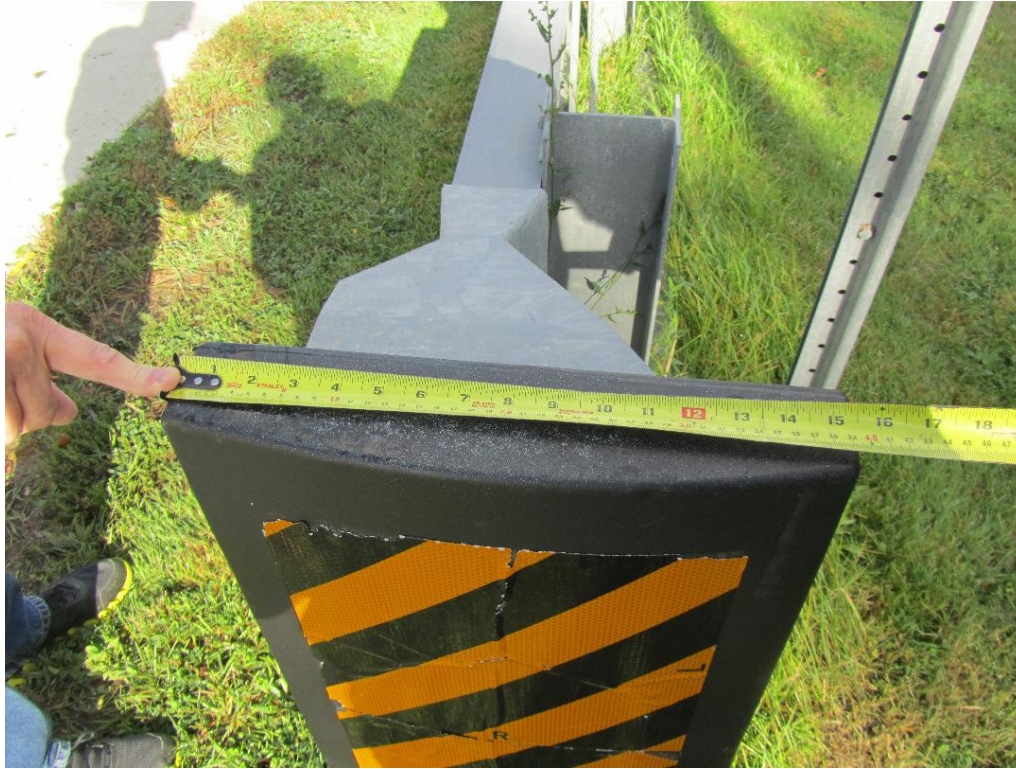
Figure 84: Measurement indicating typical, 15.5 inch wide cover of end plate.

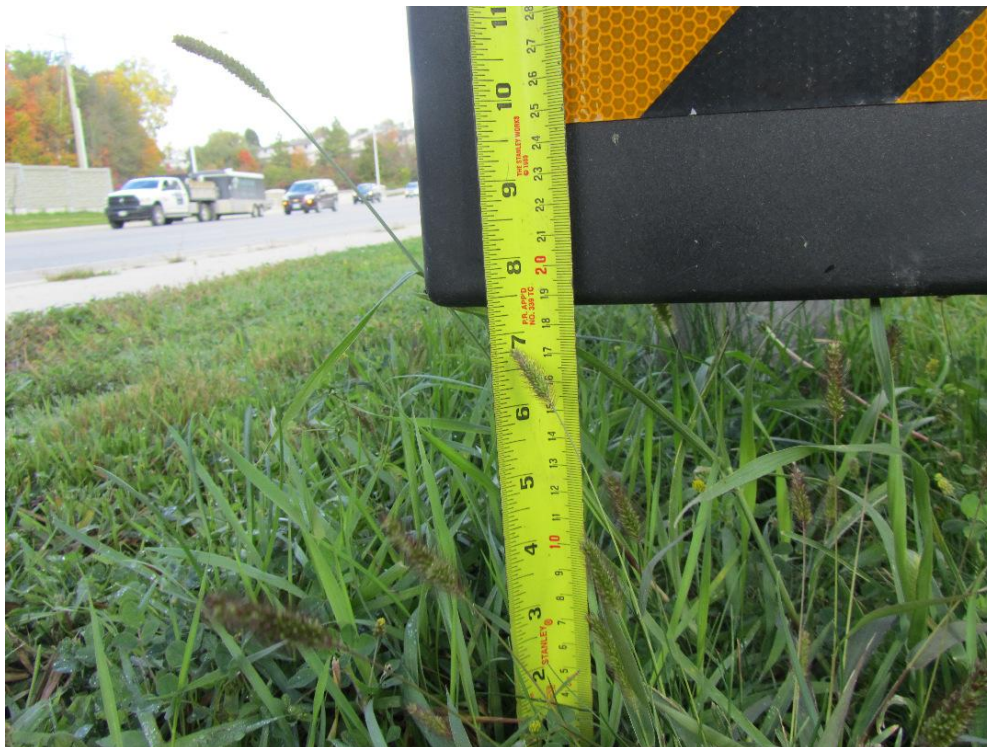
Figure 85: Base of plate cover is 7.25 inches above the ground.

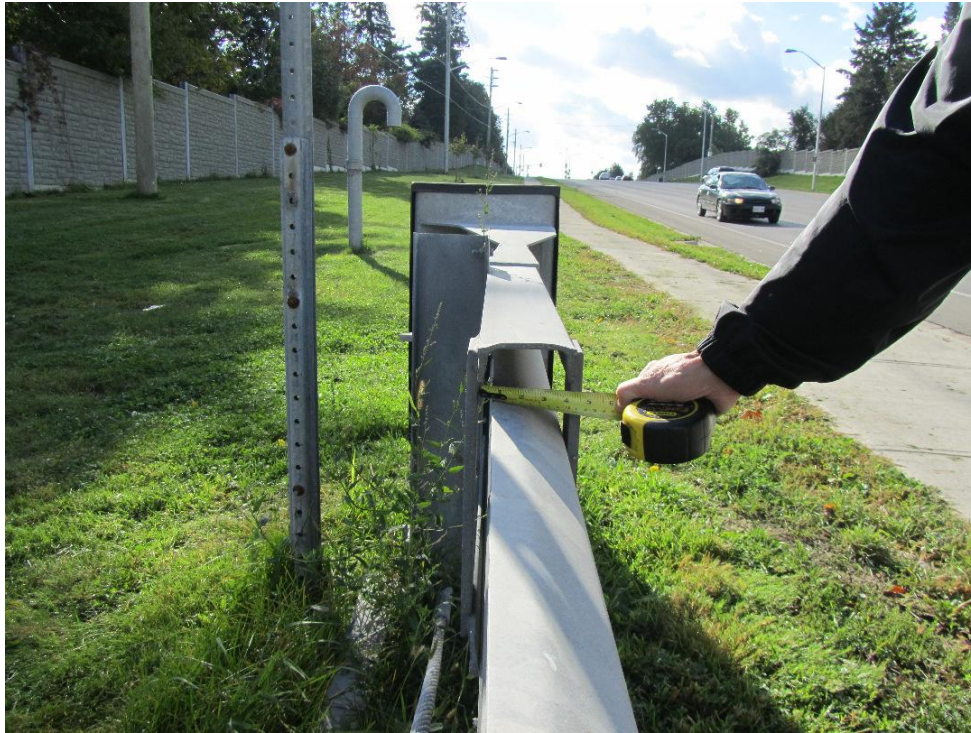
Figure 86: View showing measurement being taken of the width of the channel. Note that the rail is positioned low within the channel.

In a number of installations we have observed some minor differences in the installation height of the end plate and the vertical angle of the plate with respect to the length of the rail and how high the rail rests within the channel. All these minor alterations may be of little consequence to the system's performance, however, we simply do not know.

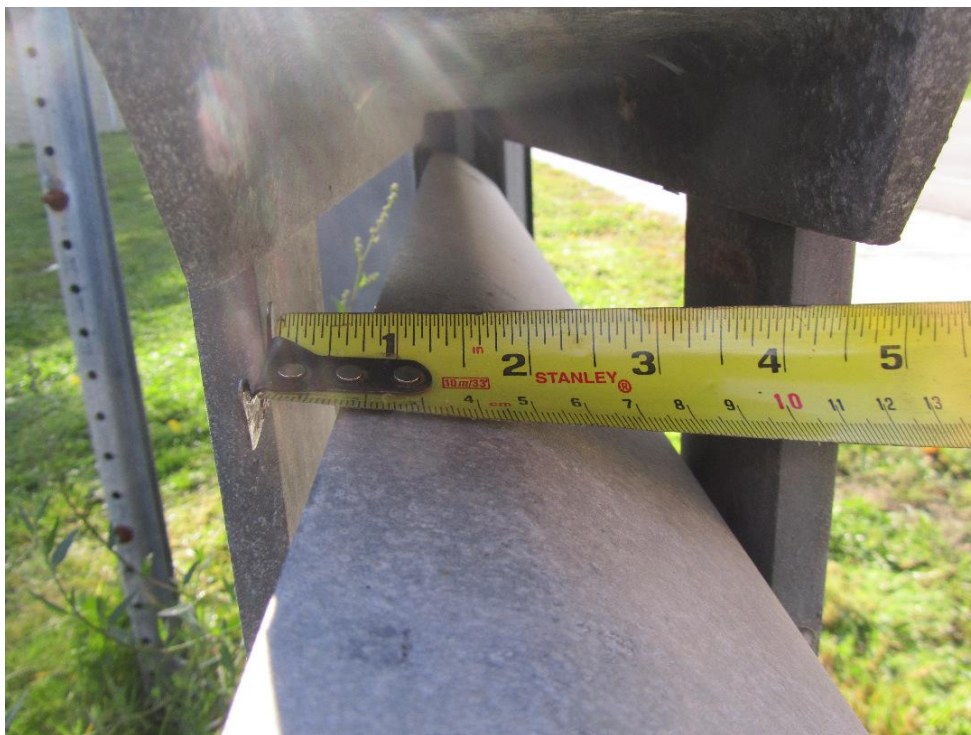
Figure 87: Measurement indicating typical 4 inch wide channel.

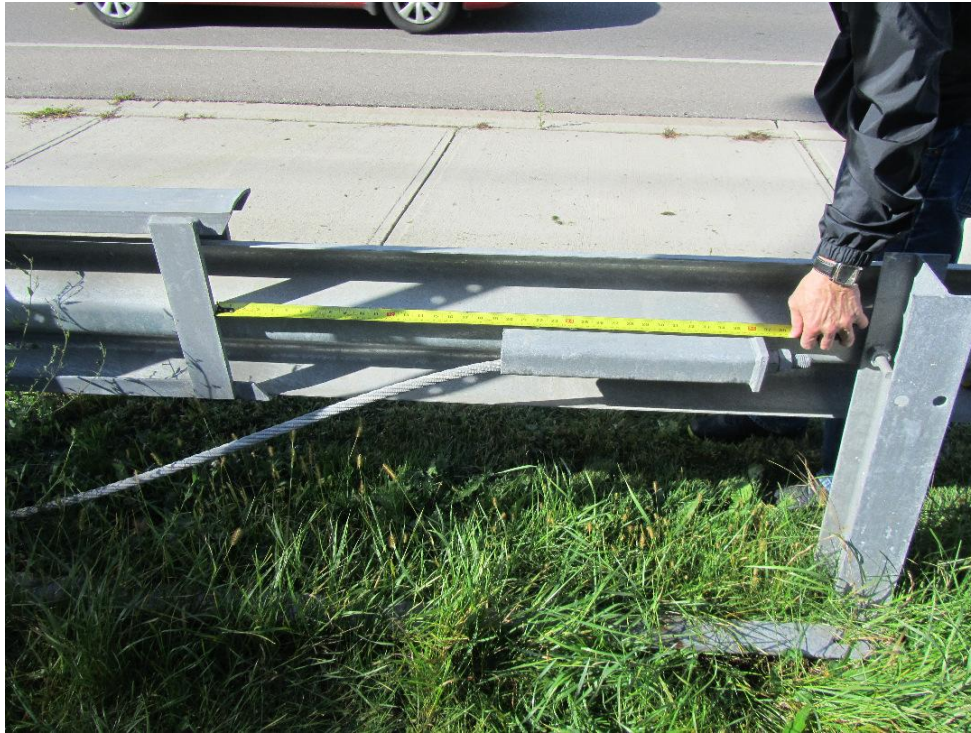
Figure 88: View of standard measurement to locate the end plate with respect to the guard rail.

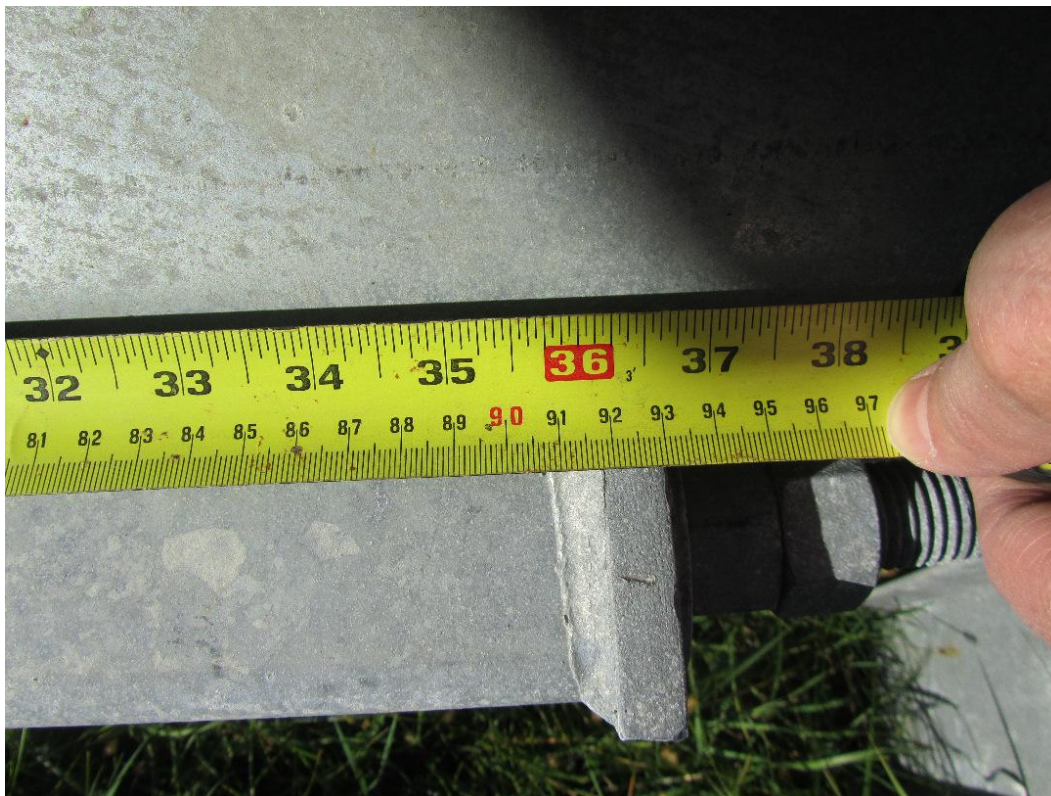
Figure 89: Result of standard measurement indicates a distance of 36.5 inches.

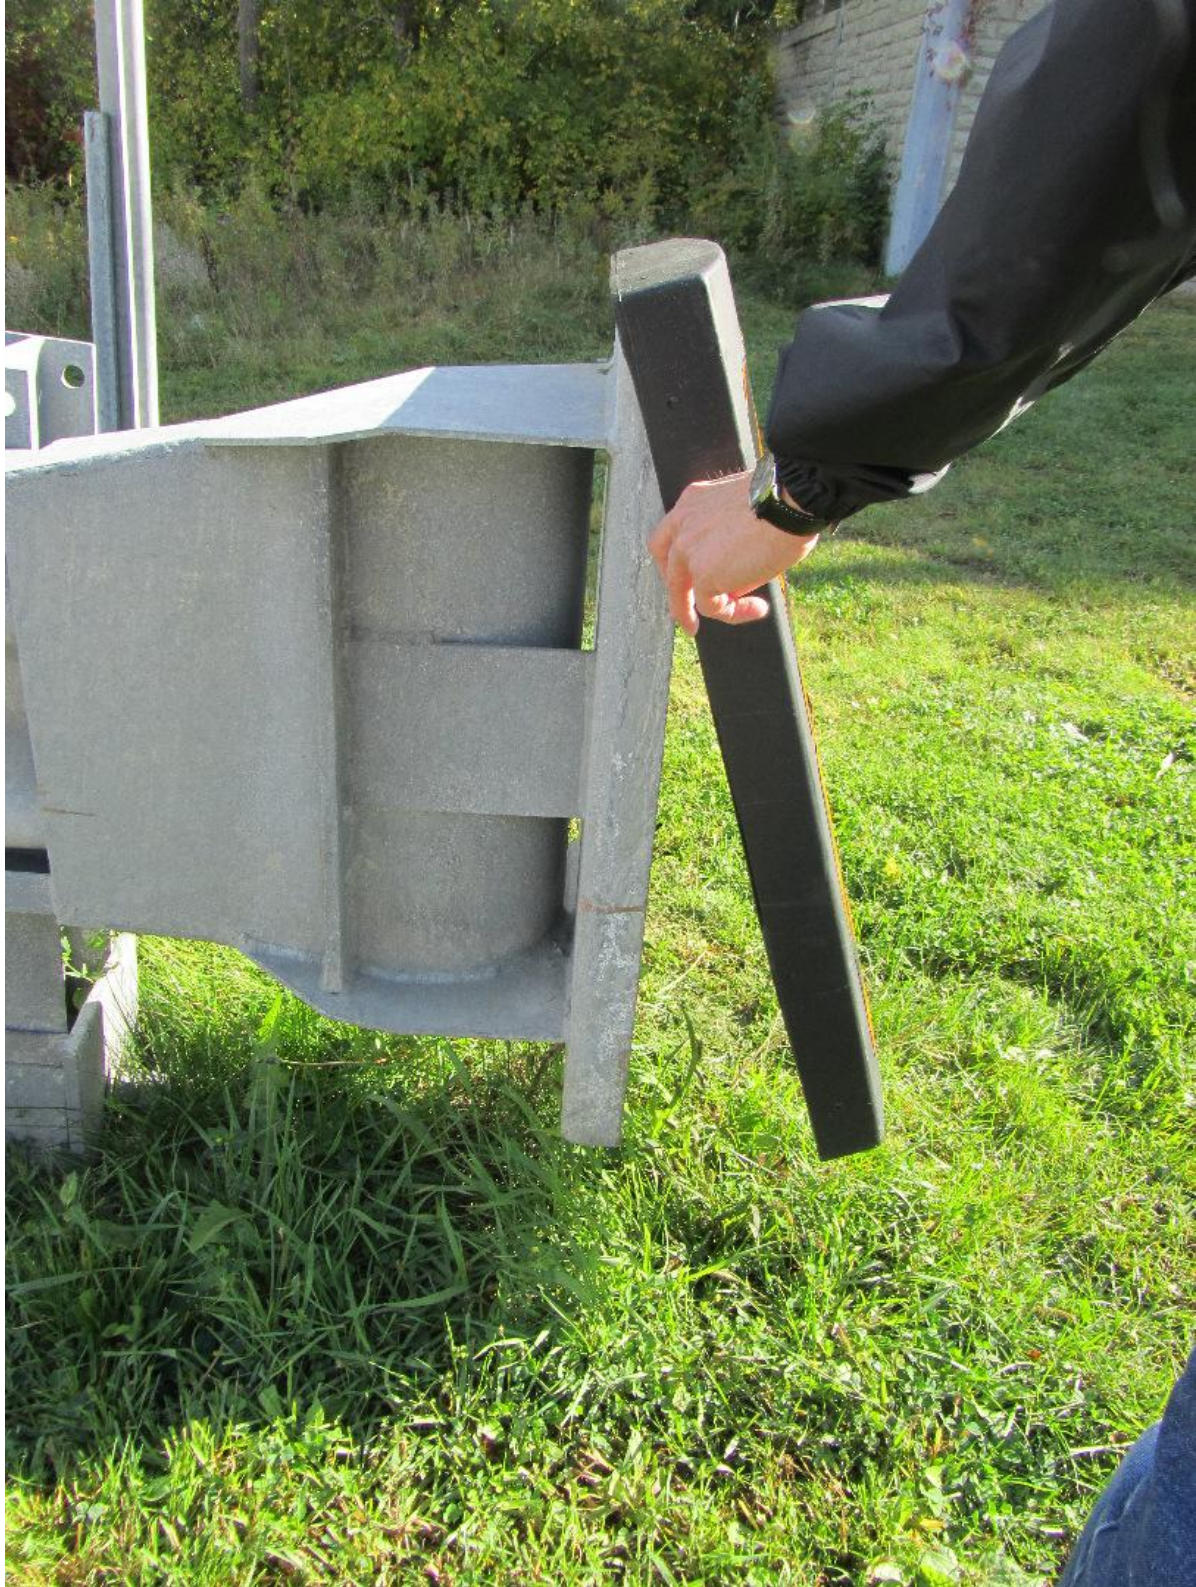
Figure 90: Because there are no plastic clasps to secure the cover to the end plate the cover can easily become dislodged from its position.

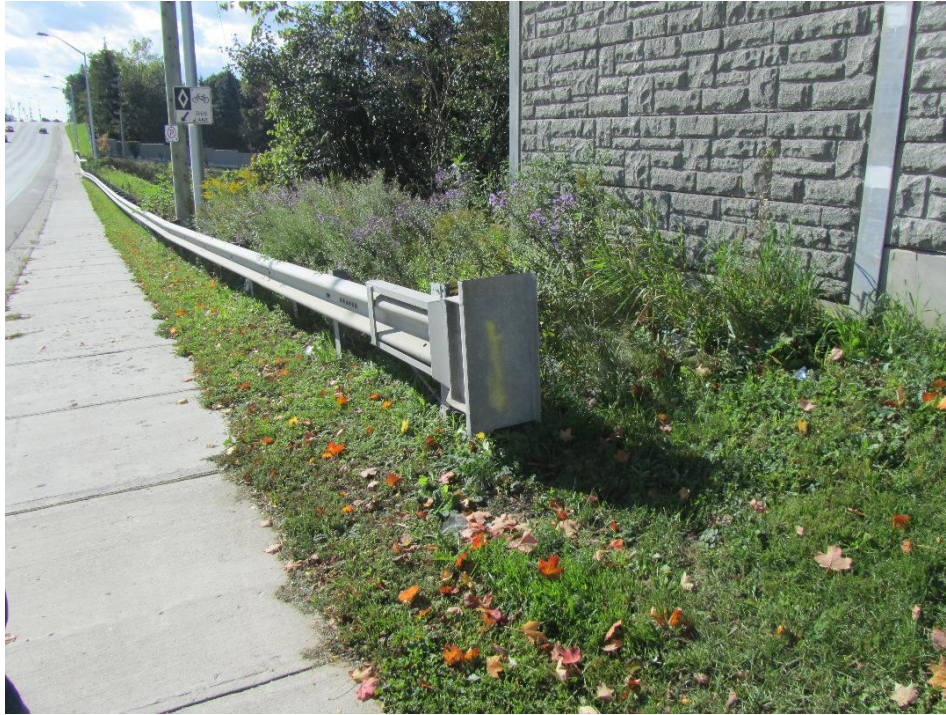
Figure 91: Overall view of north end cap of west guardrail.

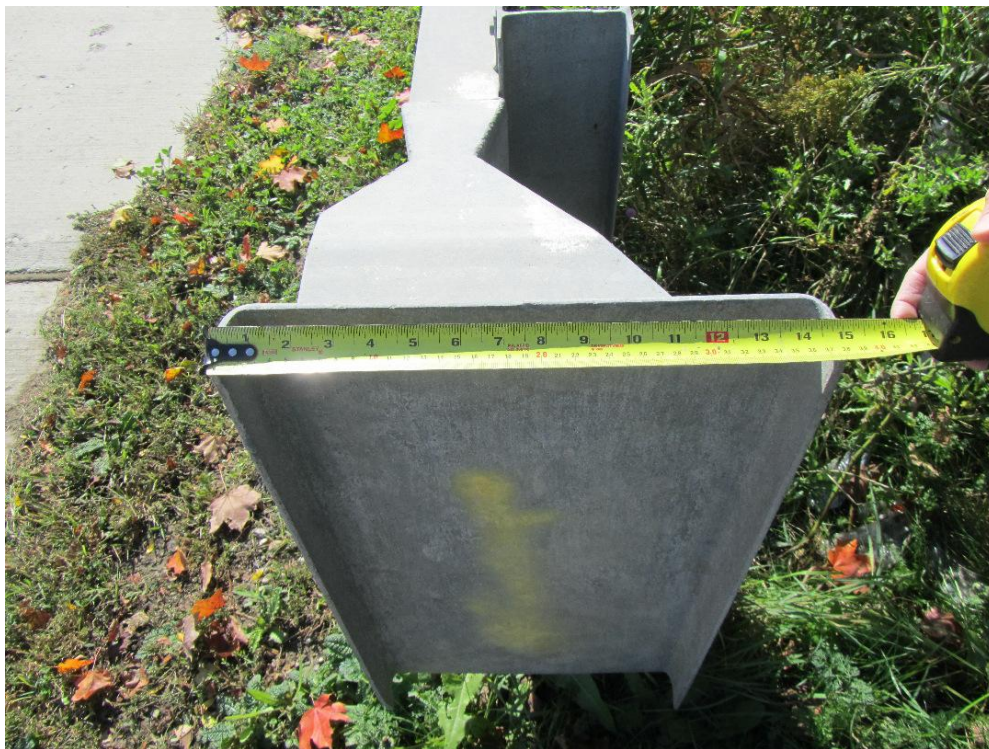
Figure 94: Measurement of north end plate (15 inches wide) which is missing its cover.

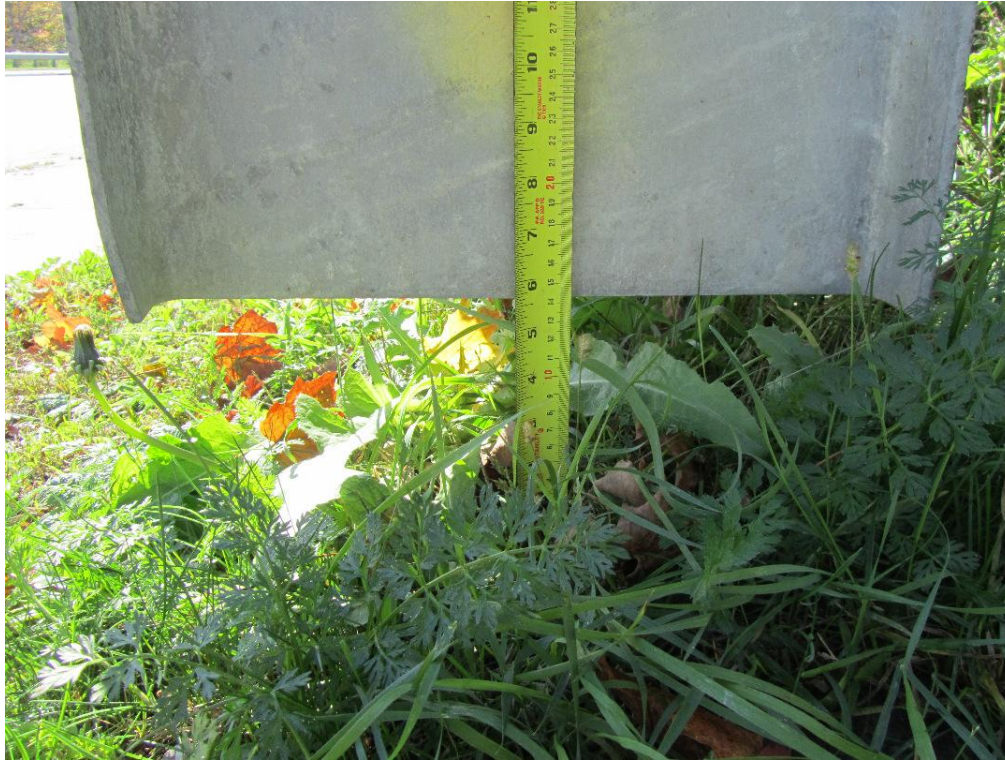
Figure 95: View of base of end plate which is 5.5 inches above the ground.

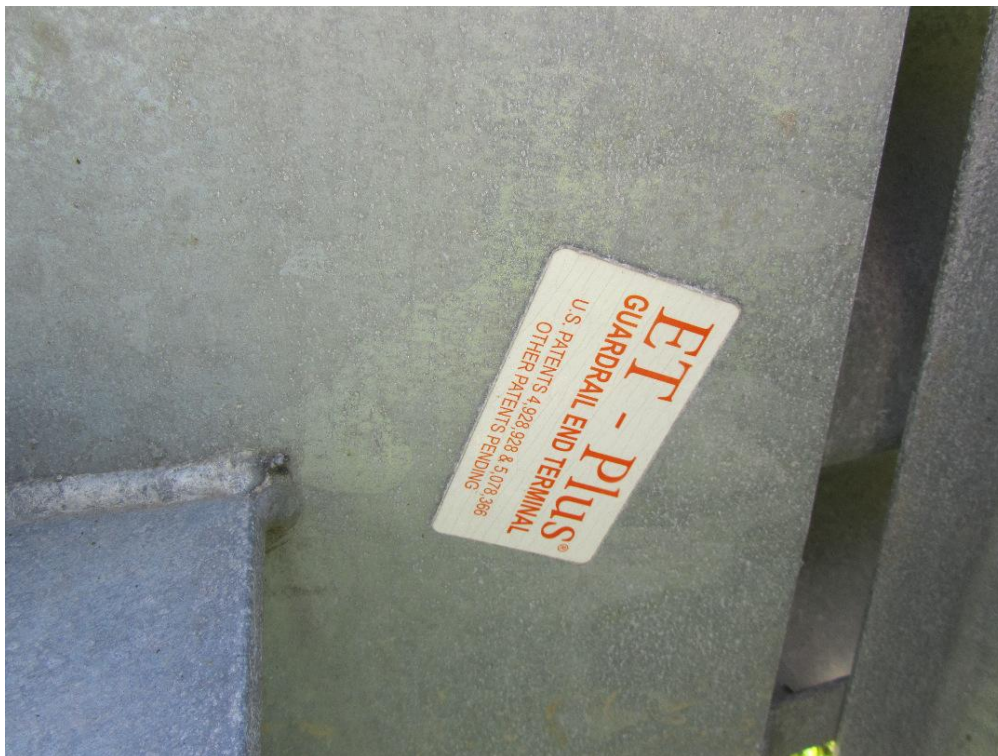
Figure 96: View of tag attached to the end plate indicating that this is one of the ET-Plus terminals that is the subject of the defect allegations.

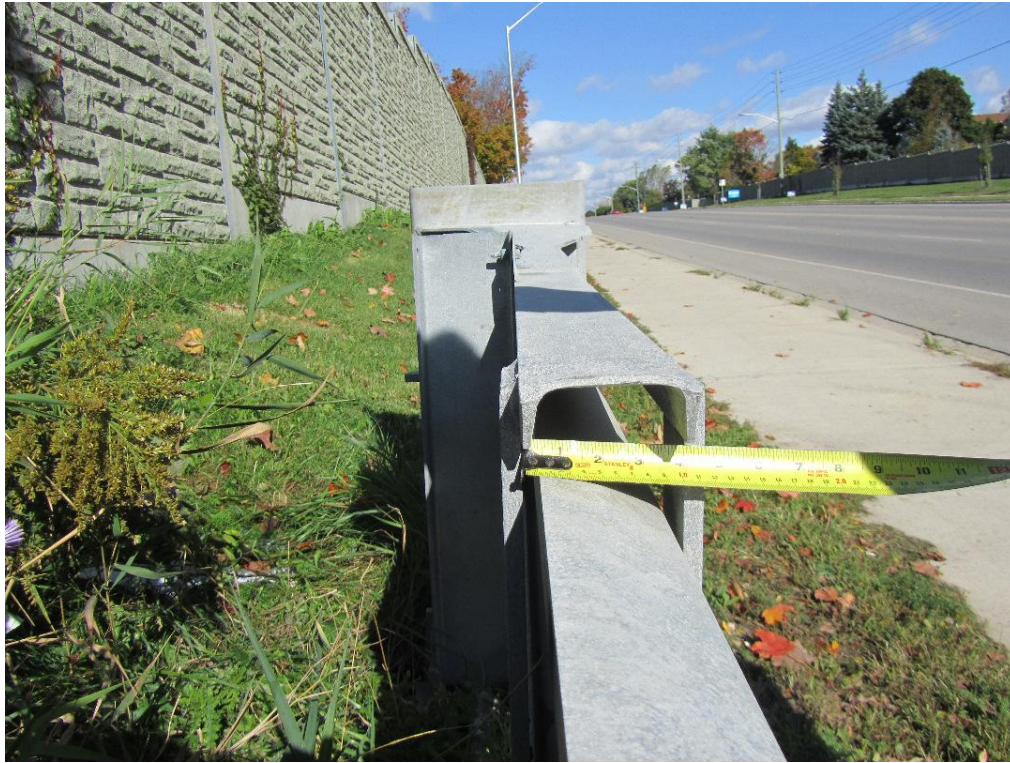
Figure 99: View of measurement indicating that the channel is 4 inches wide and that the rail is positioned at a low level within the channel.

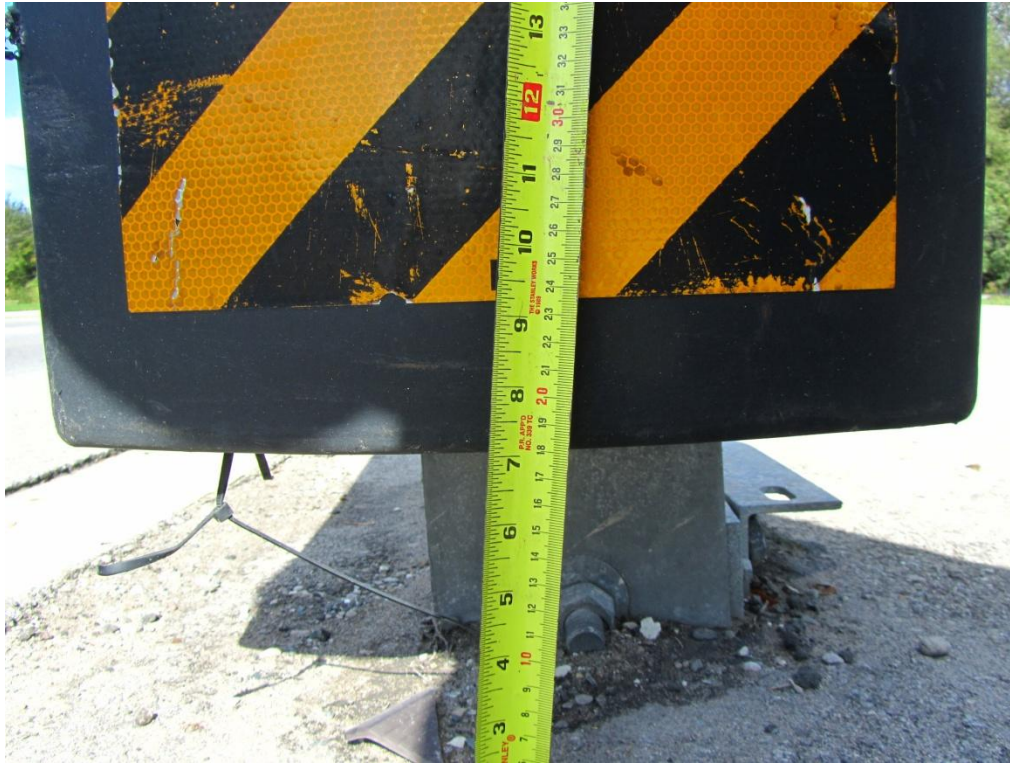
Figure 105: Measurement indicating that the base of the cover is 7 inches above the ground.

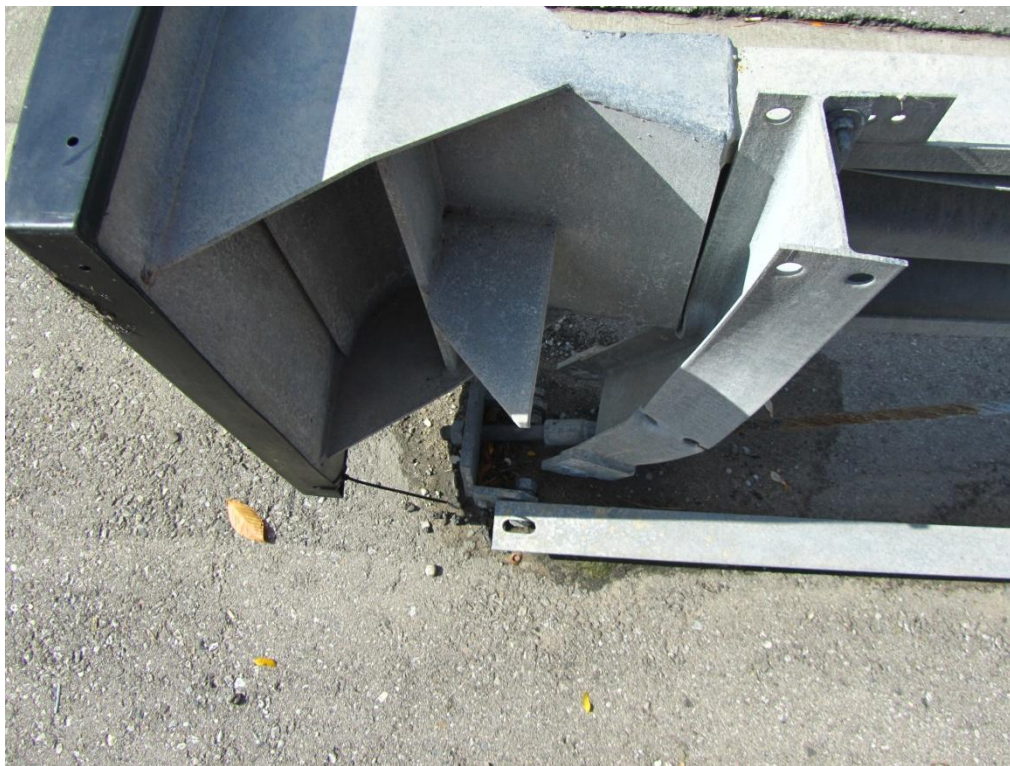
Figure 106: Vertical view of damage near the end plate indicating that the plate has been pushed along the rail, likely due to a previous impact.

At several sites we have observed that the system was damaged, possibly from previous impacts, and that the system was still left in its condition, without a repair. Again, it cannot be known what level of damage could become important in changing the safe functioning of the systems.

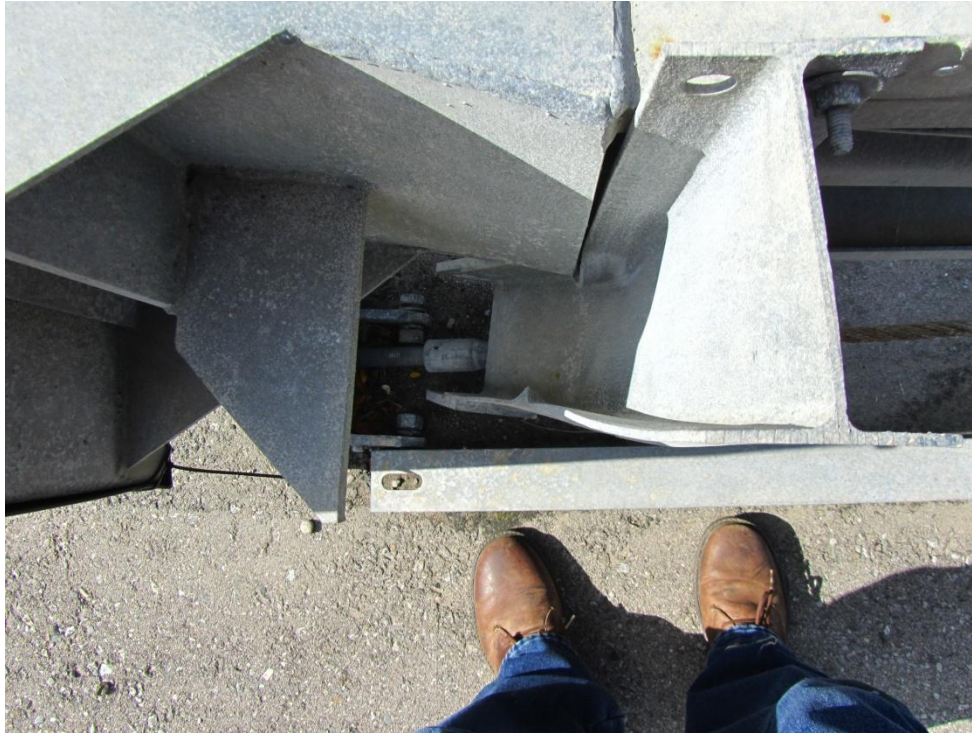
Figure 111: Top view showing how the back of the end plate has made contact with the vertical anchorage post and deformed it.

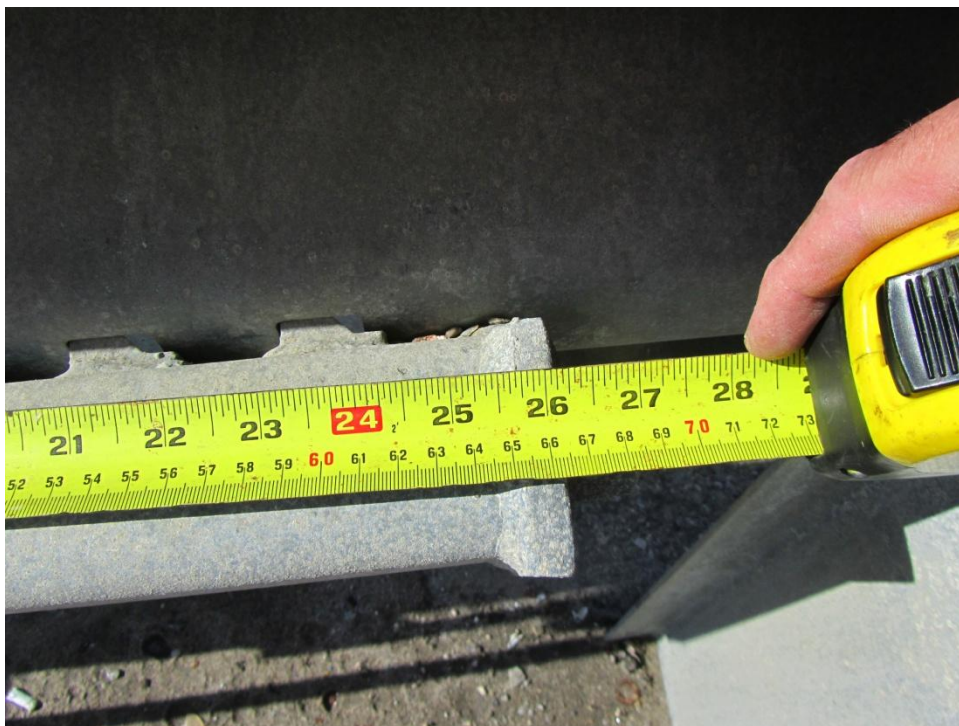
Figure 114: The result of the standard measurement of the 26 inches is about 10 inches shorter than the measurements taken at the undamaged guardrails therefore the end plate as been displaced along the rail by about 10 inches.

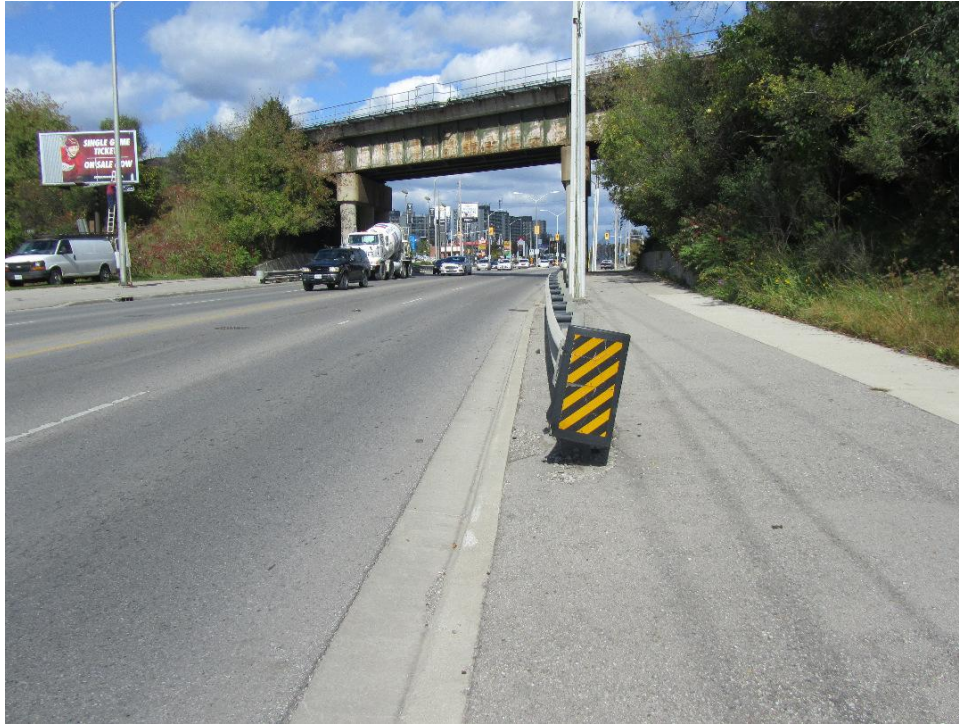
Figure 115: Overall view of 2nd End Cap of east guardrail. Note that the end plate is on an obvious non-vertical angle.

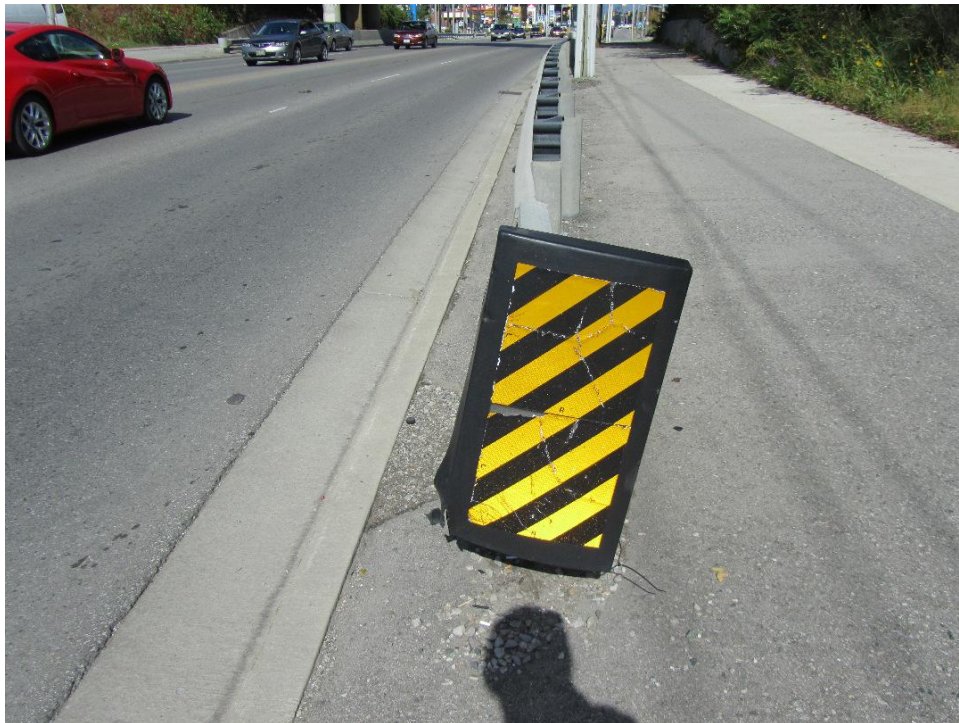
Figure 116: Closer view showing that the end plate hidden by its cover, is at a non-vertical angle.

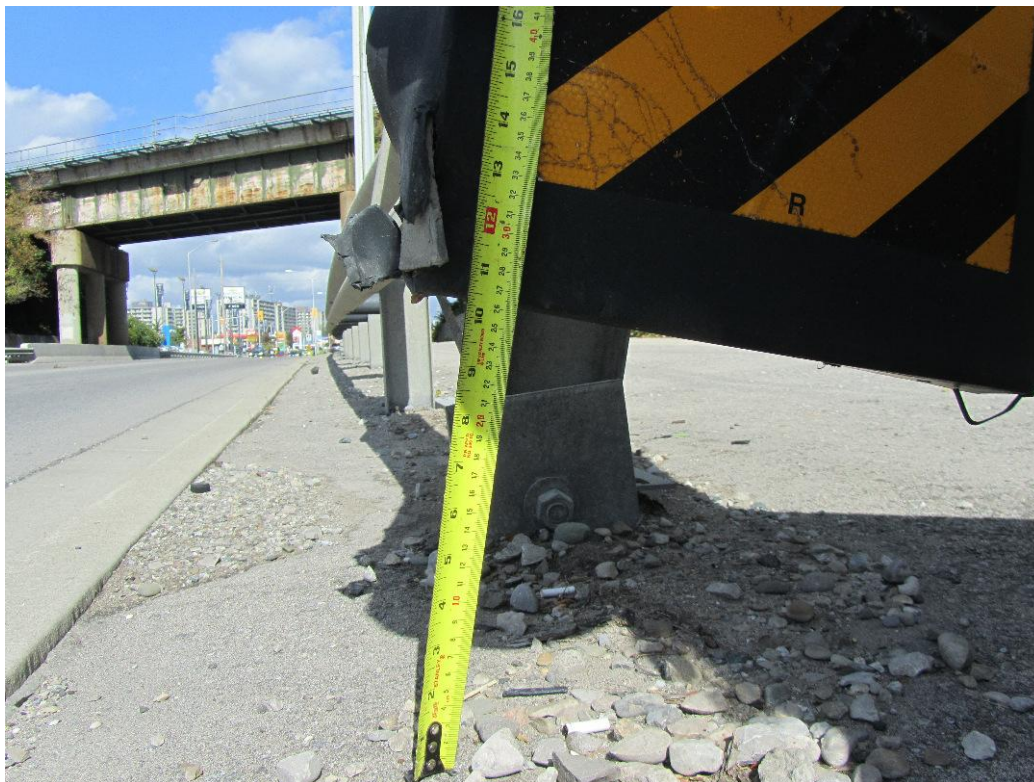
Figure 120: Measurement shows that the street side corner of the cover is about 10.5 inches above the ground.

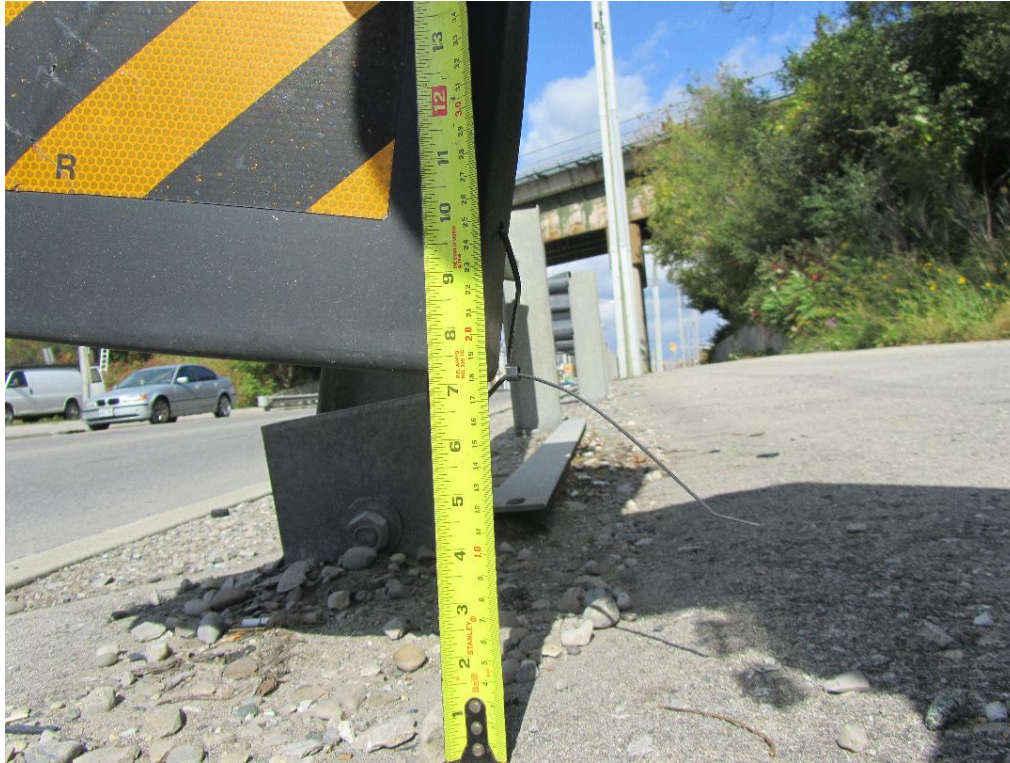
Figure 121: Measurement showing that the ditch side corner of the cover is about 7.25 inches above the ground. This indicates the substantial resting angle of the end plate.

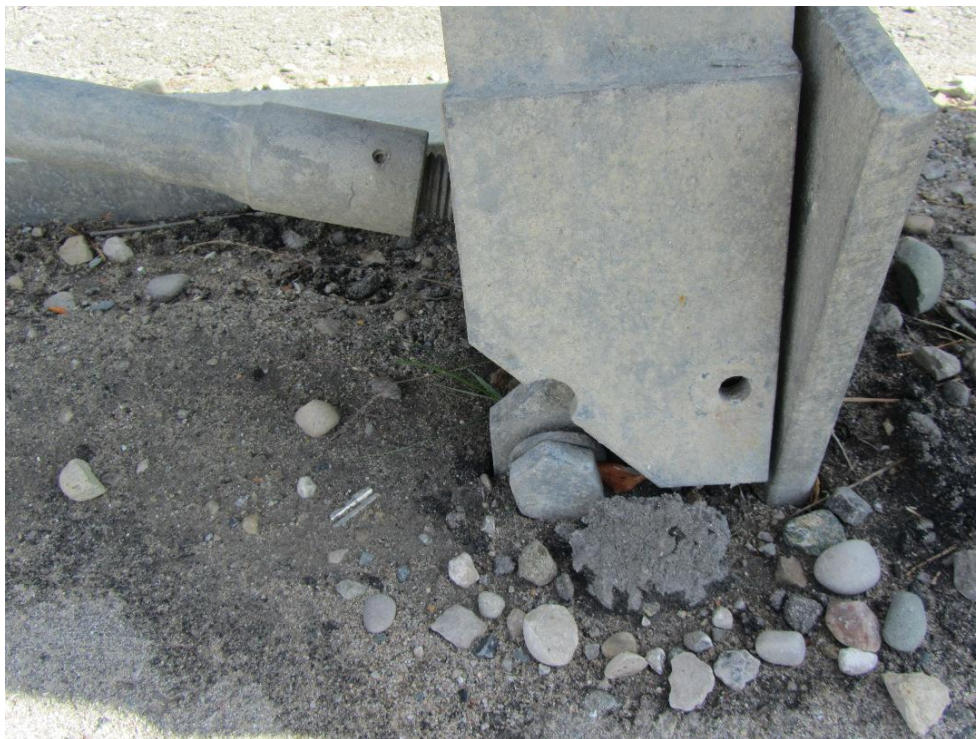
Figure 124: Close-up view of separation at the bottom anchor bolt suggesting that this was a manufactured "tight fit" only and likely designed to separate whenever the end plate sustained a dislocation.

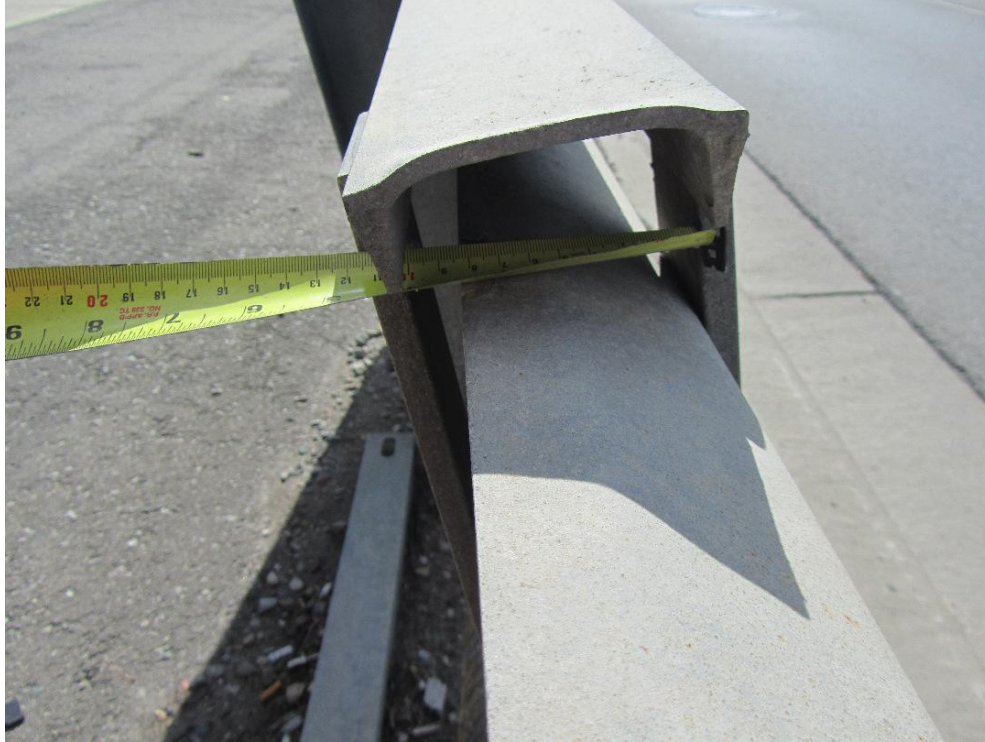
Figure 125: Measurement indicating that the channel is 4 inches wide. Note that the rail within the channel is resting at a low position.

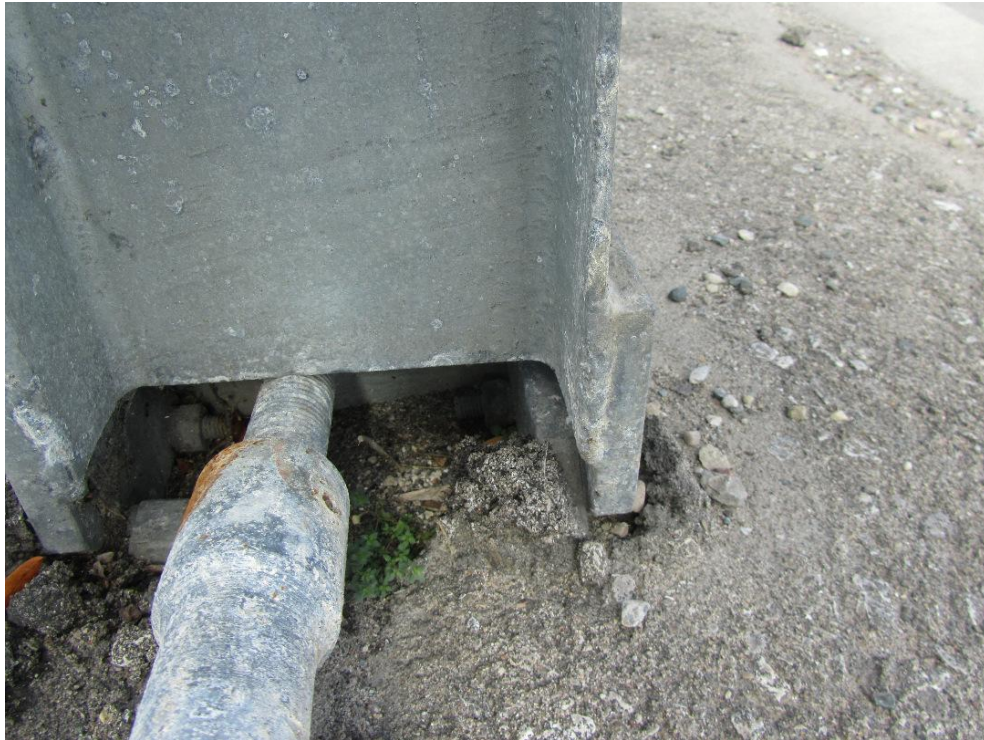
Figure 133: Closer view at the base of the vertical anchor post near the end plate where the higher asphalt pavement might interfere with the separation of the post from its "tight fit" design.

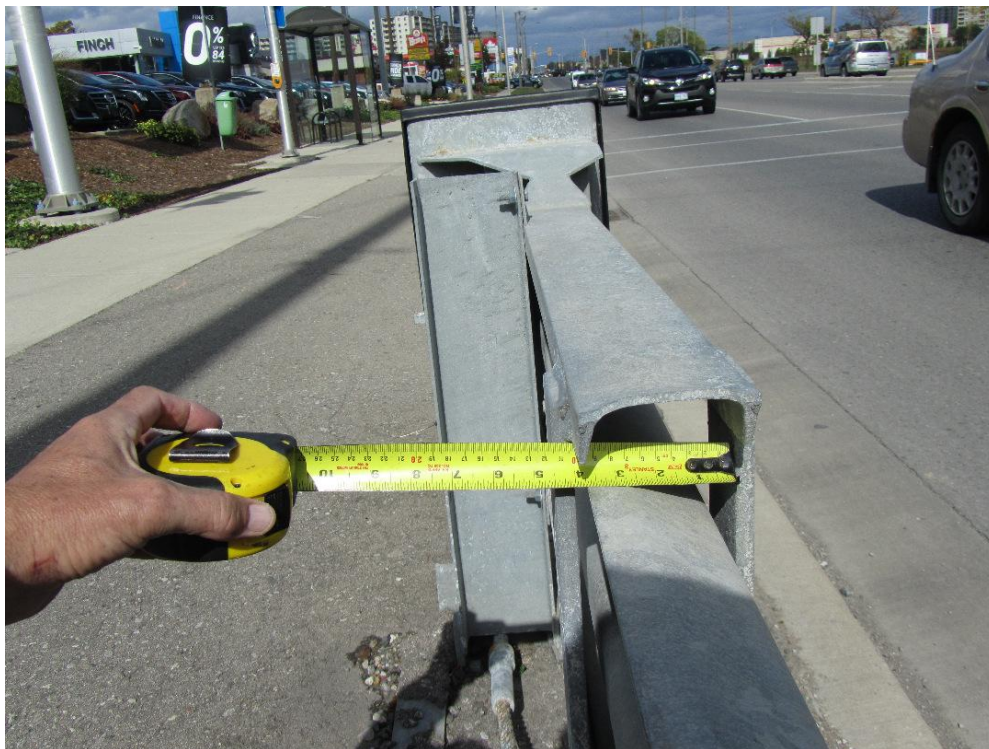
Figure 134: View of measurement indicating that the channel is 4 inches wide. Note that the rail is sitting low within the channel.
