Trinity Guardrail End Caps In & Near London Ontario - Survey of Locations & Condition

Posting Date: 09-Oct 2014

Survey of Trinity End Cap Location & Condition

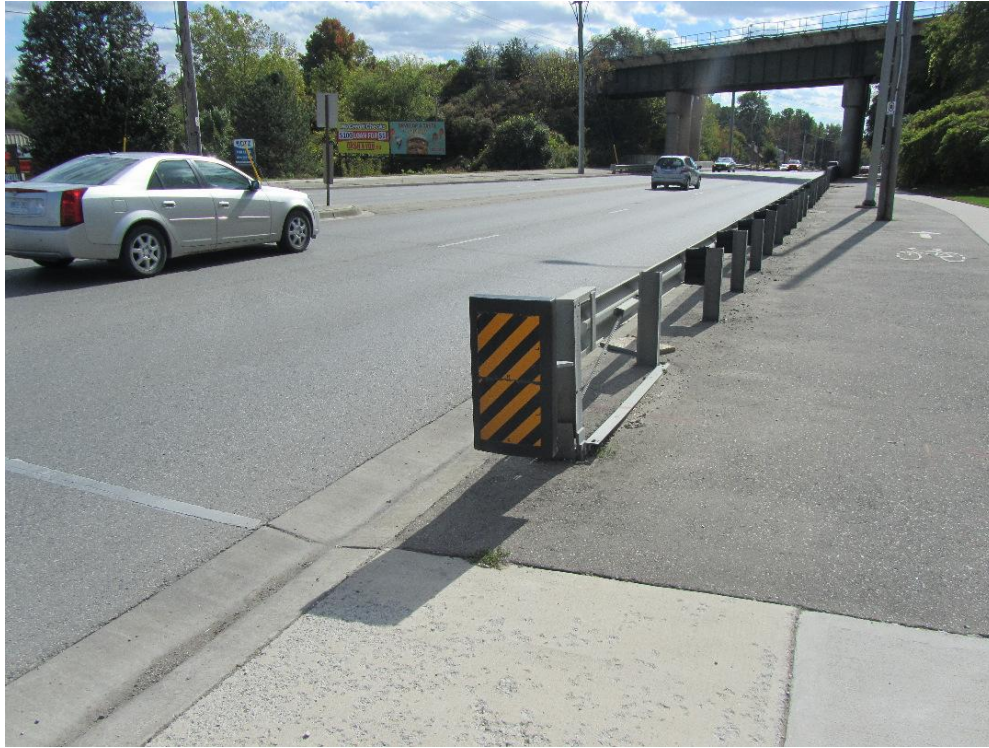
Figure 139: Overall view of 2nd end cap at the west guardrail.

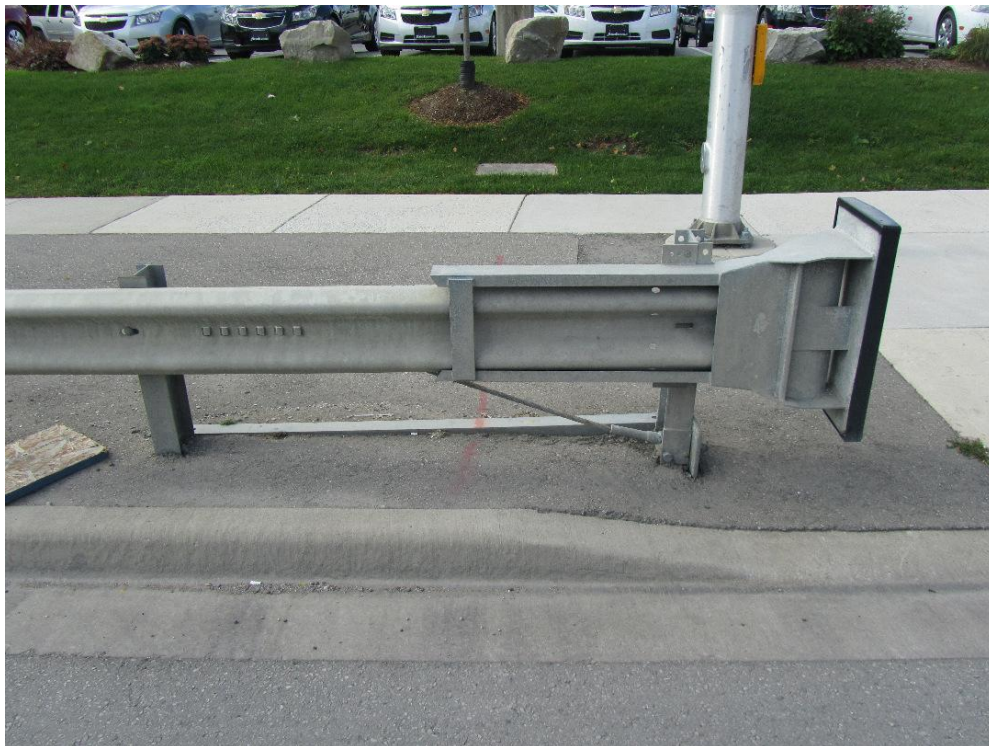
Figure 140: Street side view.

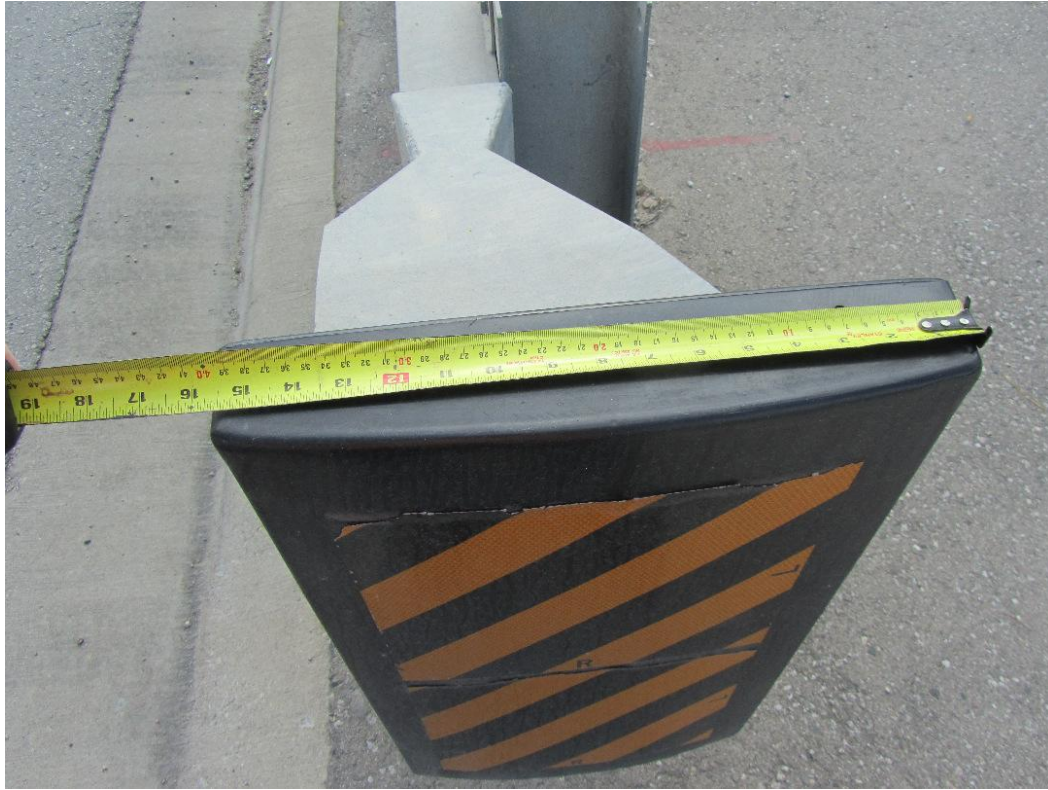
Figure 141: Measurement indicating that the end plate cover is 15.5 inches wide.

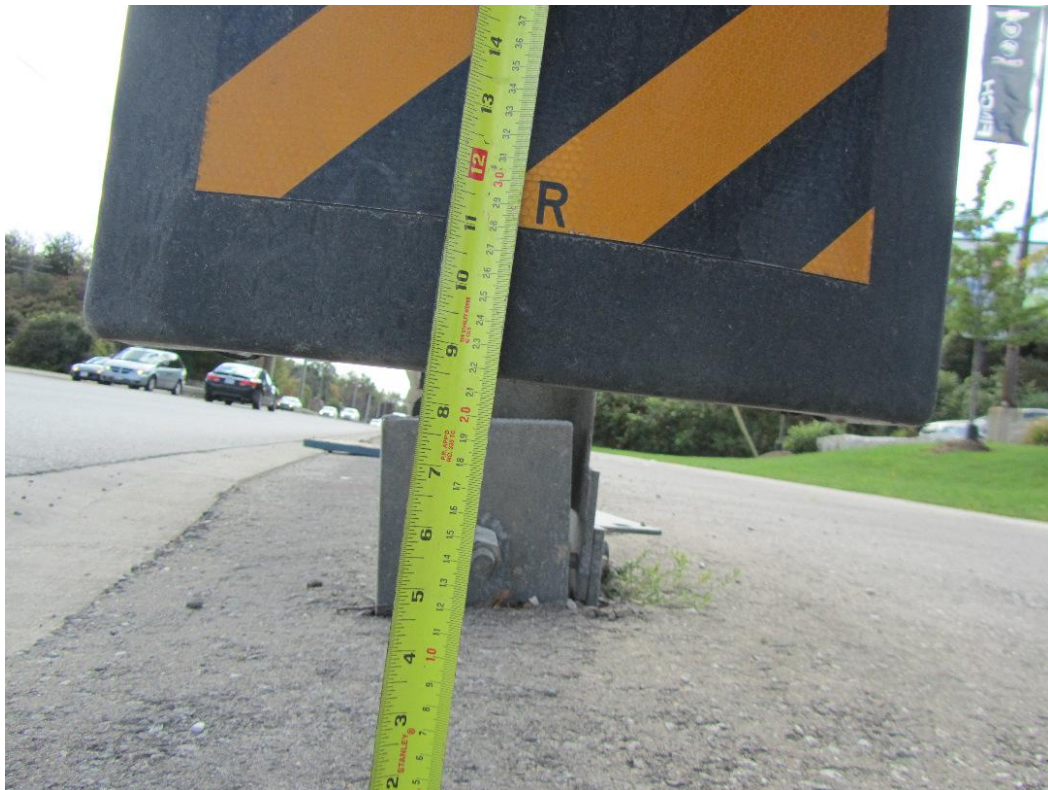
Figure 142: Measurement indicating that the base of the end plate cover is 8.5 inches above the ground.

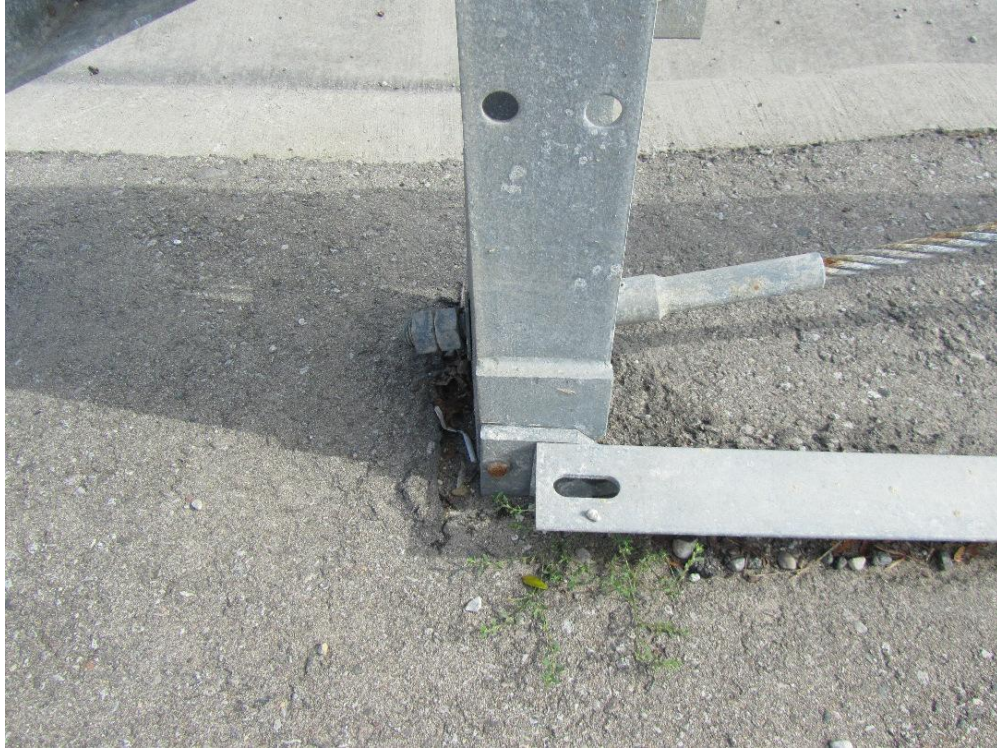
Figure 143: Ditch side view of base of the vertical anchor post just behind the end plate.

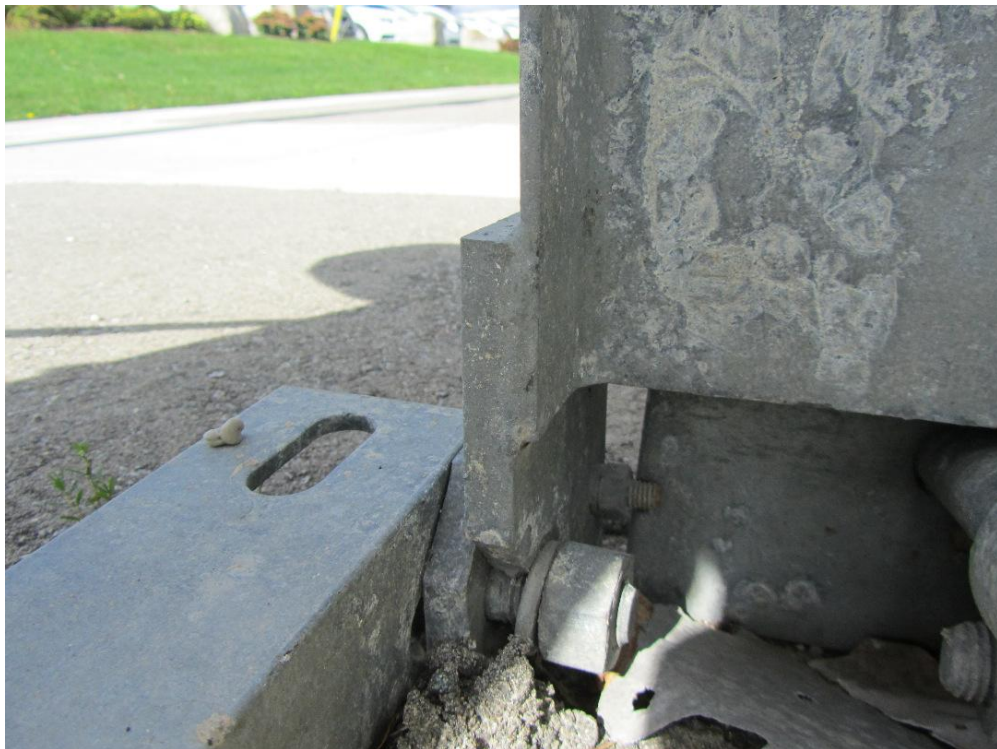
Figure 144: View showing the press fit of the base of the vertical anchor post just behind the end plate.

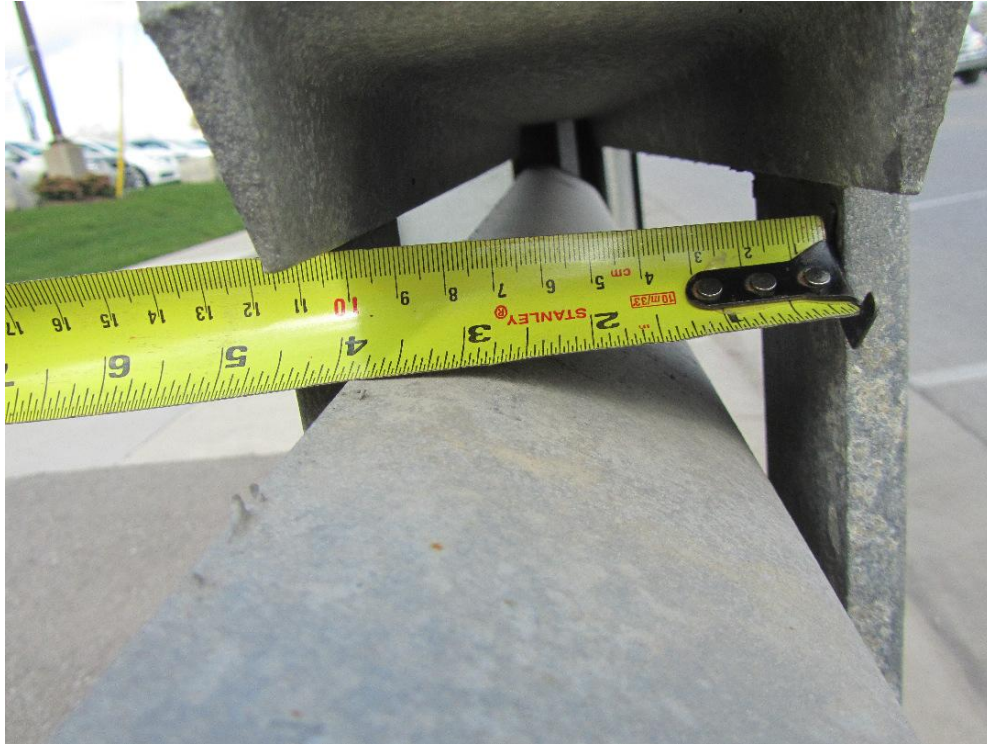
Figure 145: Measurement indicating that the channel is 4 inches wide.

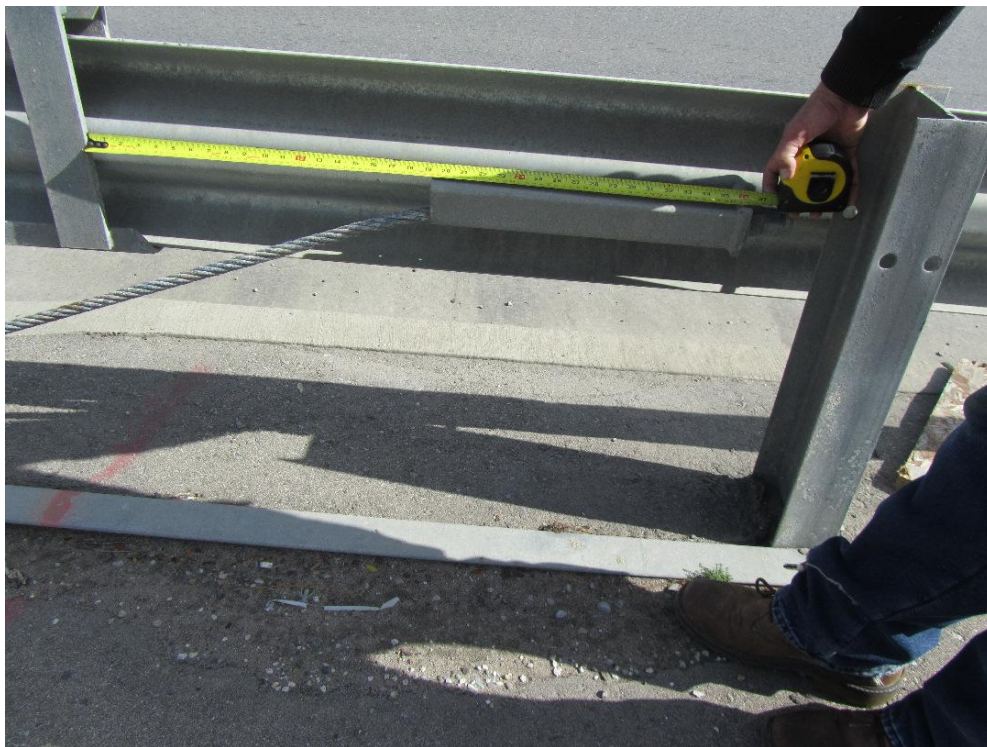
Figure 146: View demonstration the standard measurement being taken to establish the position of the end plate with respect to the guardrail.

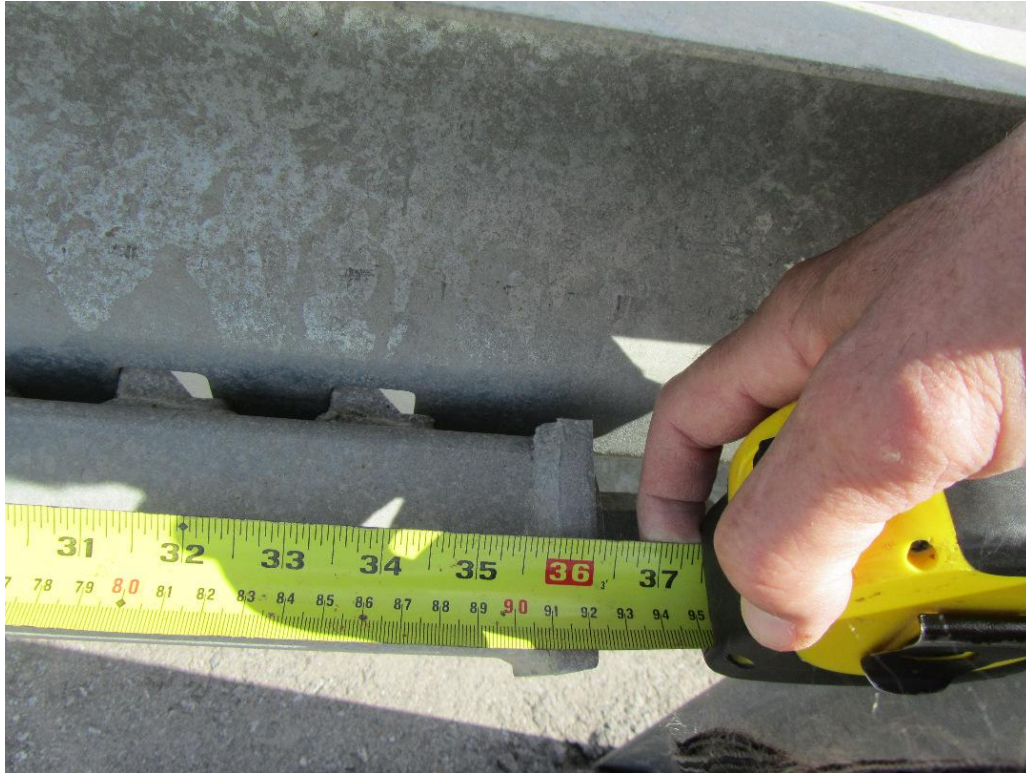
Figure 147: Result of standard measurement indicating a distance of 36.25 inches.

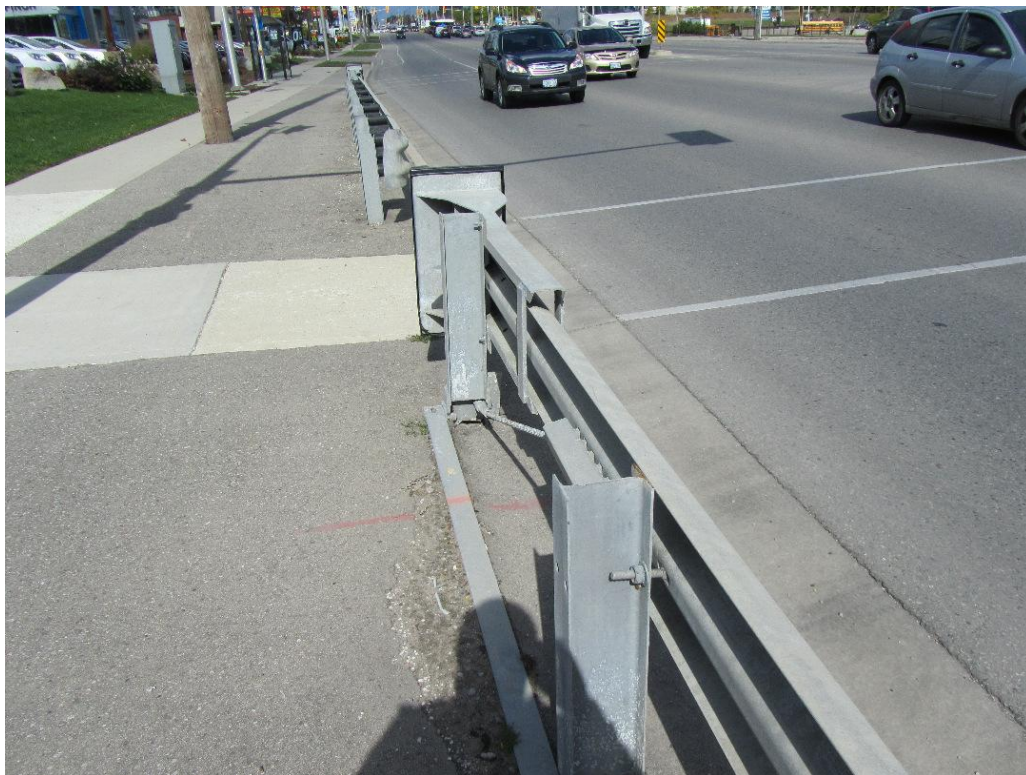
Figure 148: Overall view of guardrail position with respect to the road.
